CIVIL AERONAUTICS BOARD

AIRCRAFT ACCIDENT REPORT

NORTHWEST AIRLINES, INC.
BOEING 720B, N724US
NEAR MIAMI, FLORIDA
FEBRUARY 12, 1963

SYNOPSIS

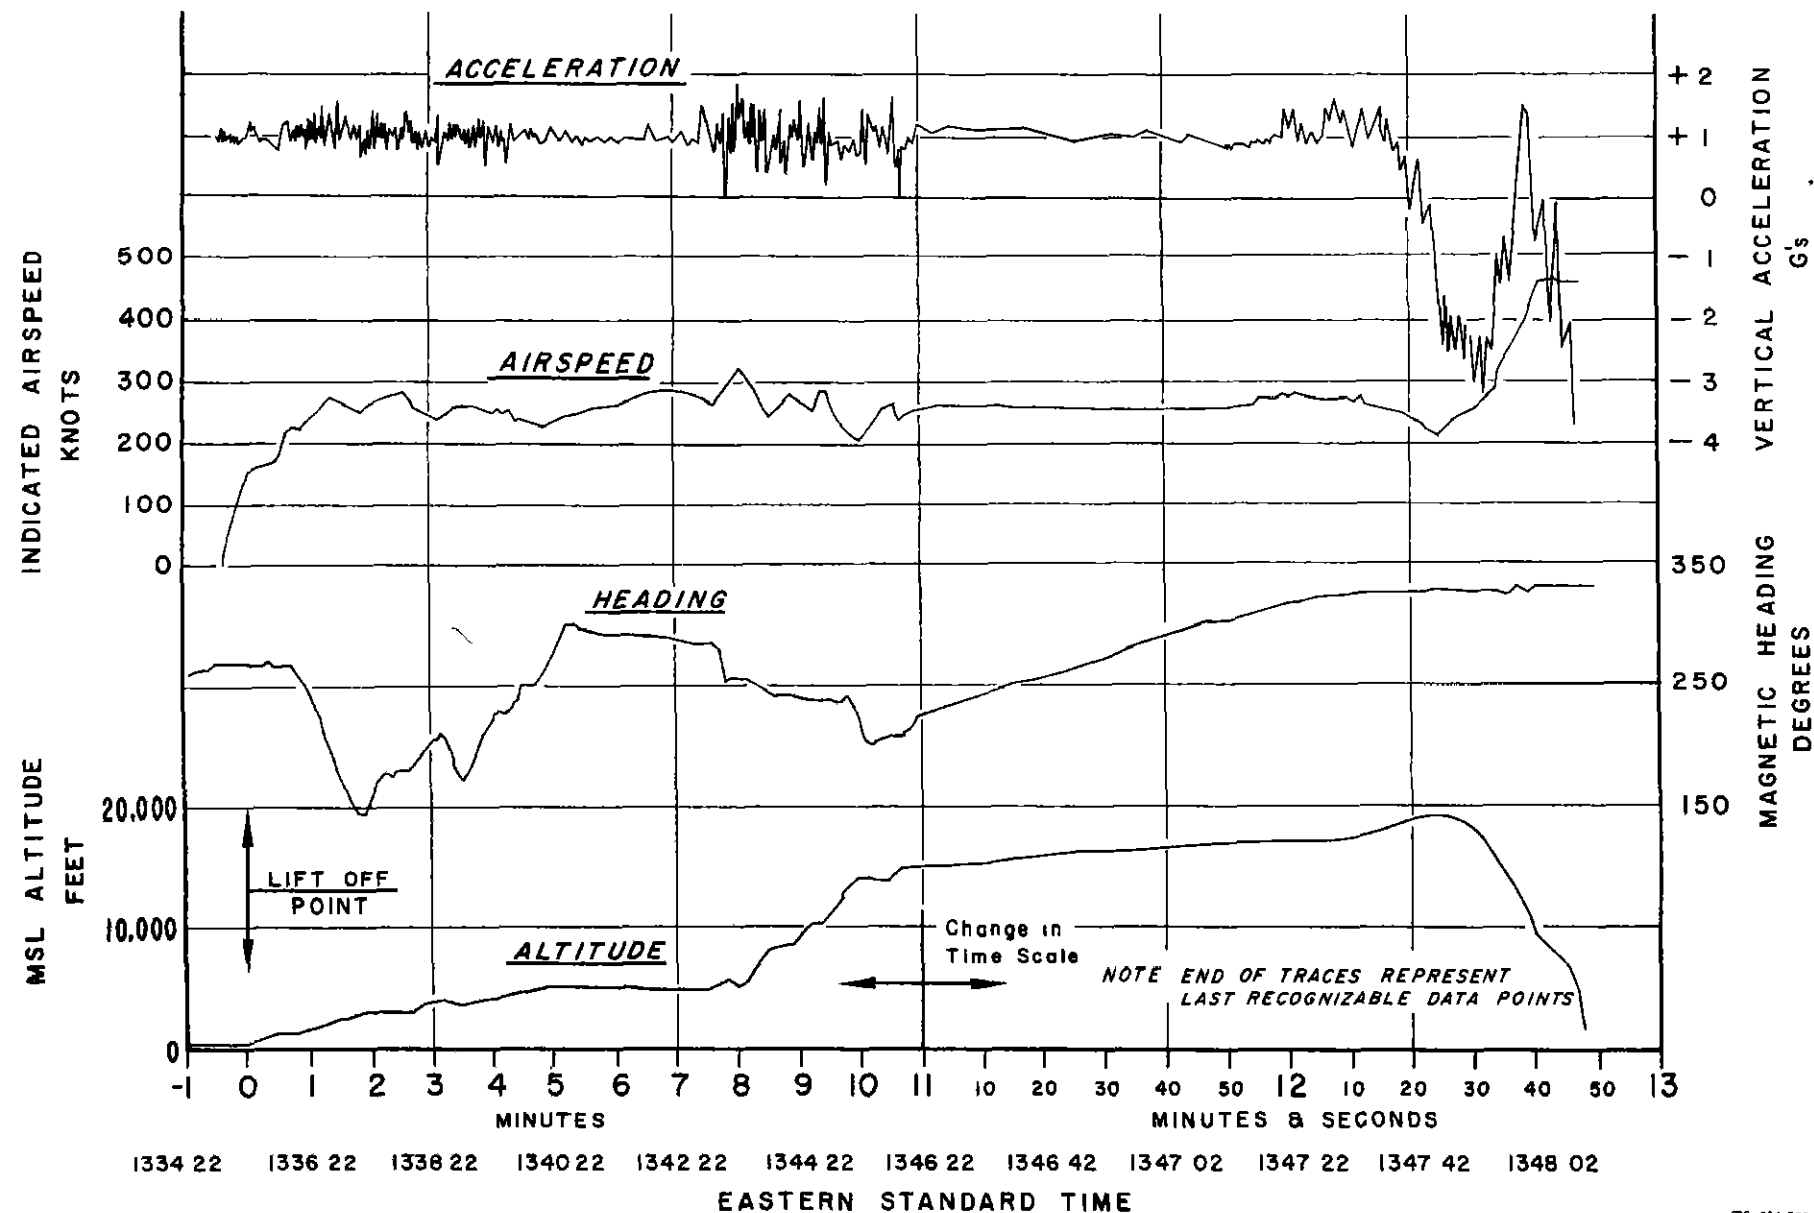
FLIGHT RECORDER DATA
NWA BOEING 720-B N724US, MIAMI, FLA., FEBRUARY 12, 1963
FAIRCHILD FLIGHT RECORDER, SERIAL NUMBER 1071

The aircraft was equipped with a Fairchild flight recorder which scribes oscillographic traces of in-flight pressure altitude, indicated airspeed, magnetic heading, and vertical acceleration as a function of time. The read-out of the flight recorder tape from Flight 705 (See Attachment B) indicates that following lift-off at 1335:22, a series of turns to headings of south, southwest, west, and northwest were accomplished while climbing to 5,000 feet in light turbulence. At 1342:46, as a climb was begun, heavier turbulence was encountered for approximately three minutes, until a left turn to 200 degrees was accomplished just prior to the cessation of the large acceleration excursion. The indicated airspeed fluctuated from 320 knots to 210 knots, and the altitude increased from 5,000 feet to 15,000 feet. The aircraft continued climbing from 15,000 feet to 17,250 feet in a right turn which continued through 320 degrees while the climb ceased and altitude remained constant for about 12 seconds. At 1347:25 the altitude began increasing again and the rate of climb gradually increased to approximately 9,000 feet per minute at 1347:38. Following this the rate of climb decreased through zero at 1347:47 when the altitude peaked momentarily at 19,285 feet. During this climb the airspeed decreased from 270 to 215 knots and as the peak altitude was approached the vertical accelerations changed rapidly from $+1G$ to about $-2G$. In the next seven seconds the negative acceleration continued to increase at a slower rate, with rapid fluctuations, to a mean value of about $-2.8G$, while altitude was lost at an increasing rate. As the descent continued with rapidly increasing airspeed, the acceleration trace went from the high negative peak to $+1.5G$, where it reversed again. In the last

nine seconds of the readout the altitude trace continued to decrease, the air-speed trace increased until the stylus hit the mechanical stop, the acceleration trace increased in a negative direction, and the heading remained fairly constant at 330 degrees. The final maneuver from the onset of the climb at 1347 25 lasted approximately 45 seconds.

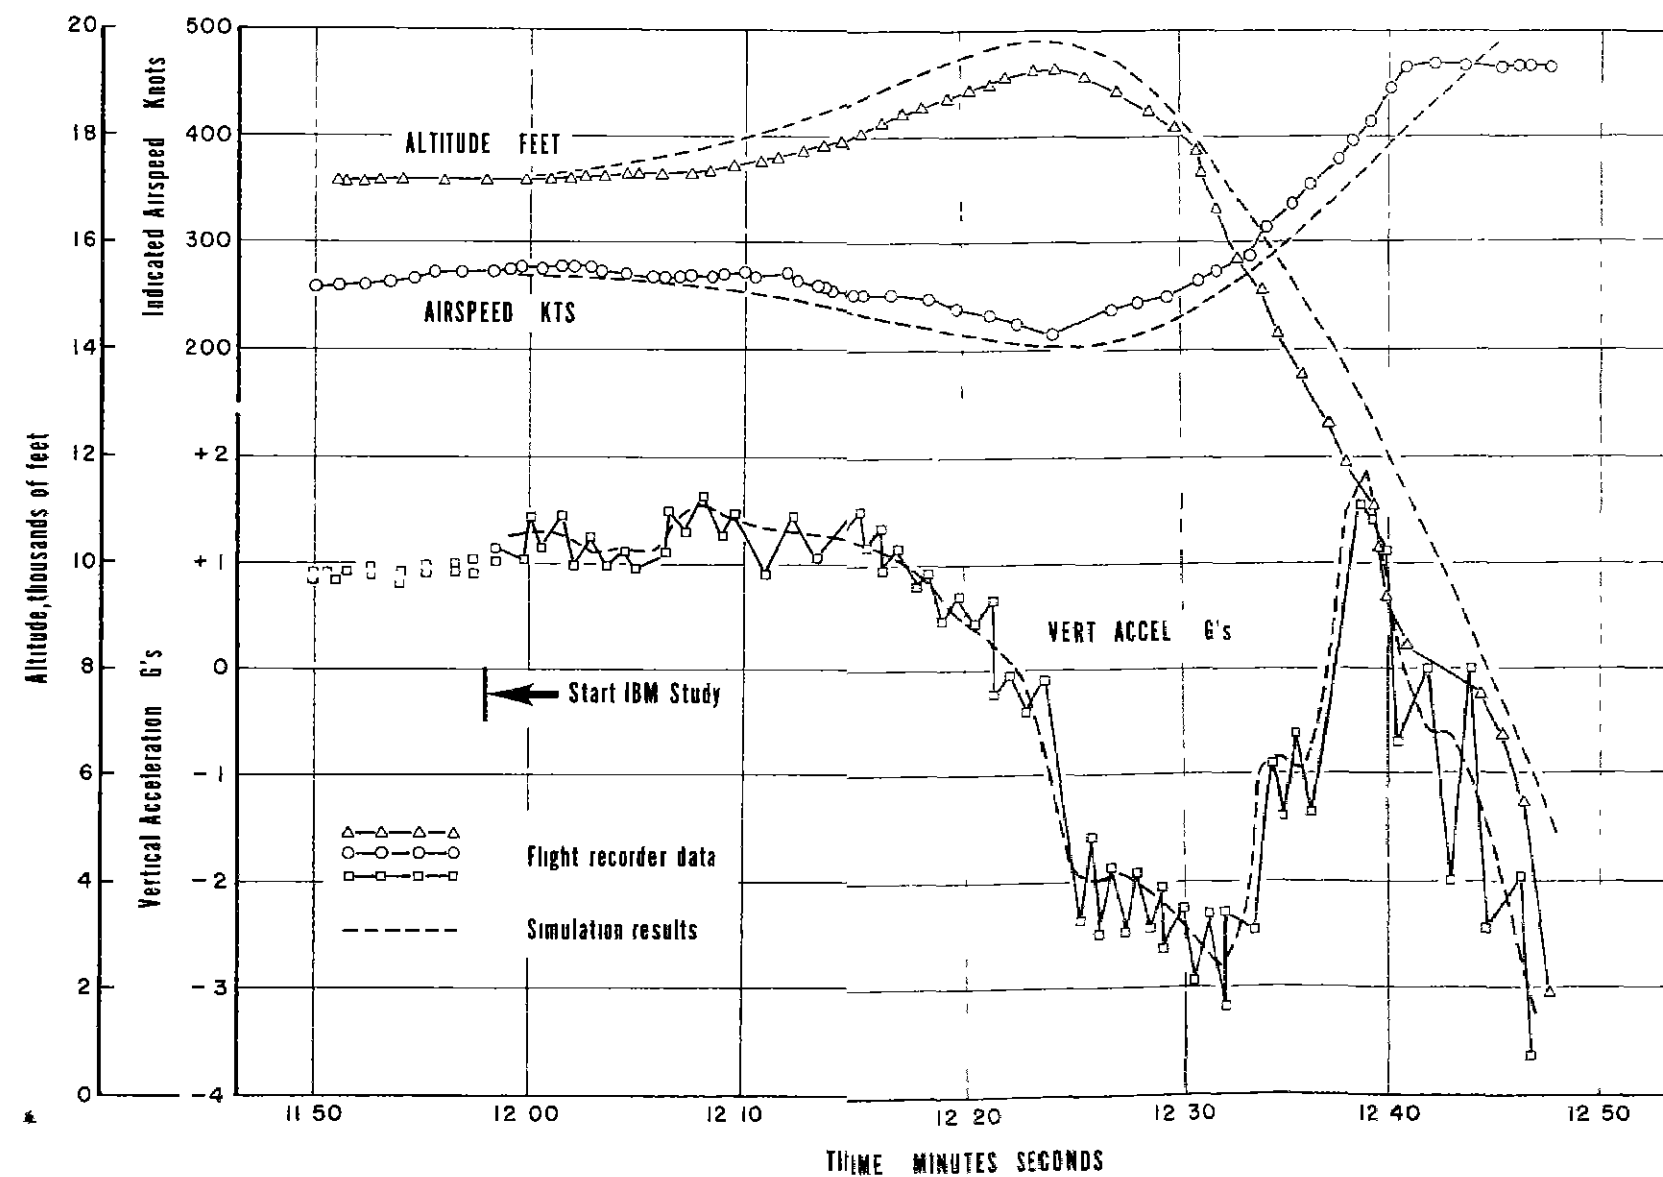
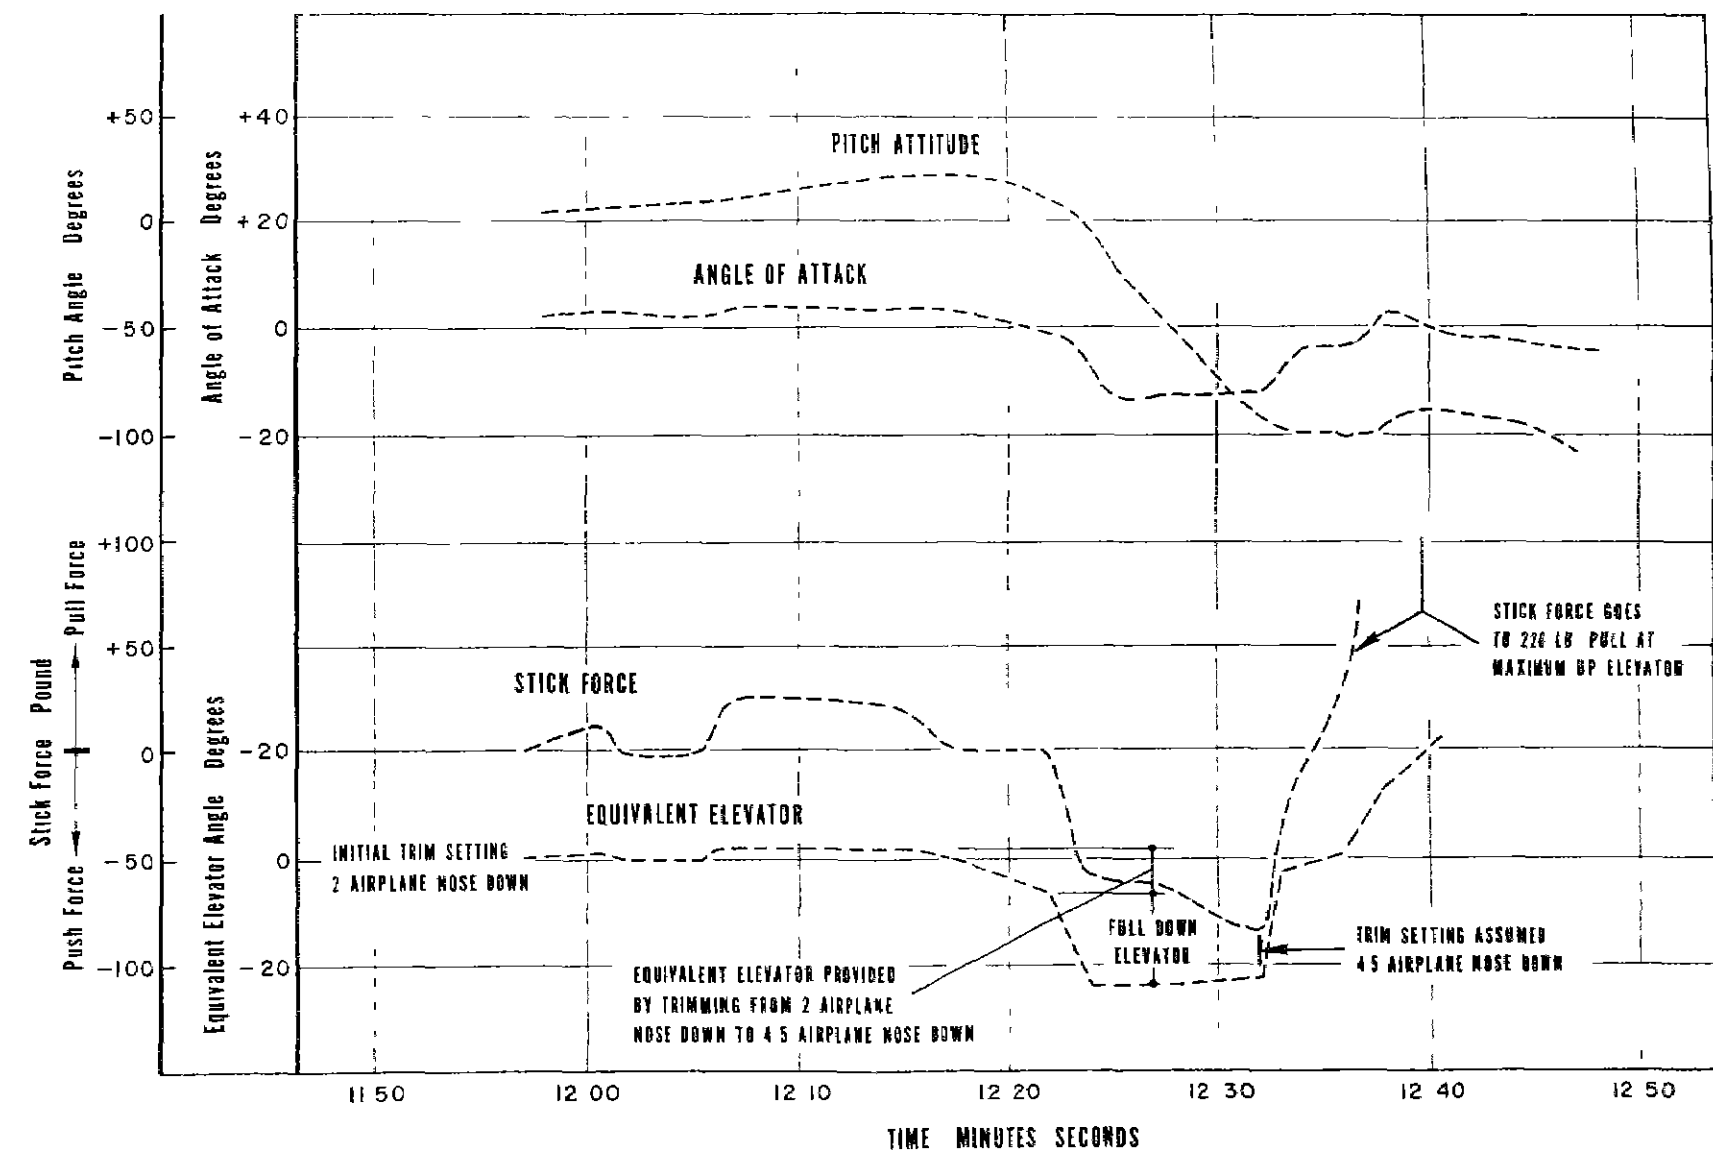
COMPARISON OF TRACES FROM FLIGHT RECORDER AND FLIGHT PATH ANALYSIS

climb, the noseover, and during at least most of the dive. The angle-of-attack, pitch attitude, equivalent elevator angle, and stick force time histories resulting from the digital computer study, coupled with the derived flightpath in space (see attachment D) provided a graphic picture of the final maneuver and a clearer understanding of the problems confronting the crew. Perhaps the most significant and initially puzzling finding was that the maneuver required (a) full nosedown stabilizer trim and full down elevator, (b) full down elevator for about eight seconds and (c) a return to the full up elevator position about nine seconds later. This one finding was perhaps the most convincing of all the evidence indicating an essentially intact aircraft down to a lower altitude, even when the inherent limitations of the overall digital study were taken into account. The Board is cognizant of the fact that this study was prepared on the basis of operation in still air, and that the study results would be somewhat modified if it had been possible to incorporate into the study the effects of the gust or draft history through which the flight was undoubtedly flying. However, it is clear that for gusts to be considered as the major contributory generating source for the initial negative G portion of the maneuver, their velocities would have to have been inconceivably high because of the large gust gradient (rate of gust onset) required and the relatively long time interval (about ten seconds) over which the negative G built up to its maximum value. Gust velocities inconceivably greater than the most severe gusts measured during the NSSP would be required. The results of the simulated gust computer studies provided still another indication that gusts and/or drafts alone, even of the type and magnitude believed to have been imposed on Flight 705, would not generate a G trace of the type shown on the flight recorder record.
